Stone River Home Inspections

Property Inspection Report

4242 Aztec Lane, muskegon , MI 49442
Inspection prepared for: John Doe
Date of Inspection: 1/5/2023 Time: 8:00 A.M.
Age of Home: 1925 Size: 1,942 Sqft
Weather: Snow 35 degrees

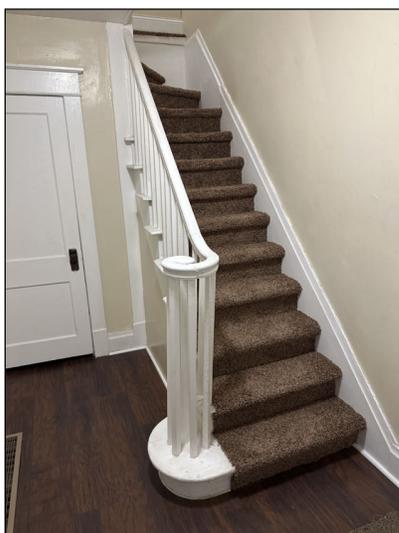
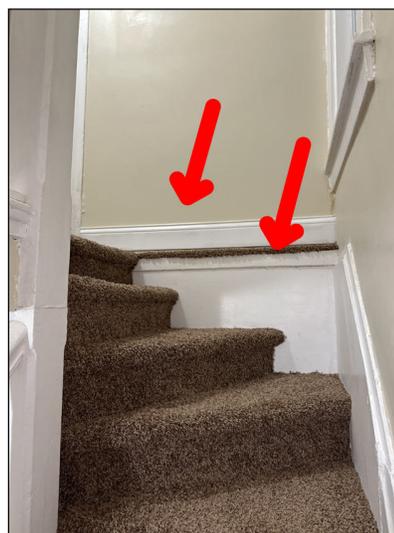
- **Recommend adding additional handrail to the stairs leading to the second floor.**

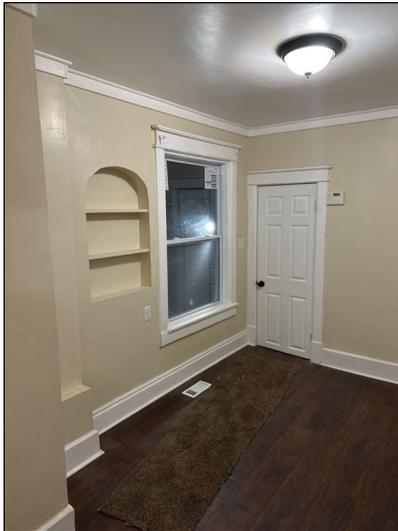
Dining room.

- Moisture stains present
- **Upstairs bathroom is leaking through the floor and down the ceiling and wall of the living room/dining room area, recommend further evaluation/repair.**

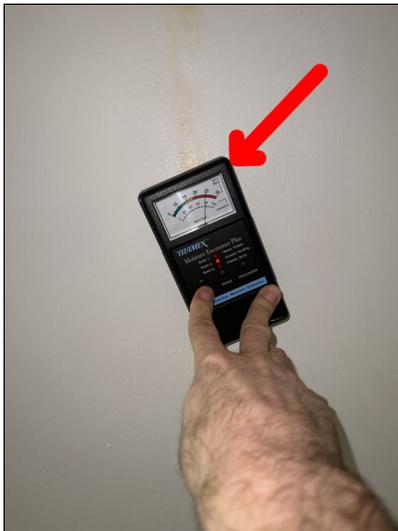
Current moisture is detected in the dining room

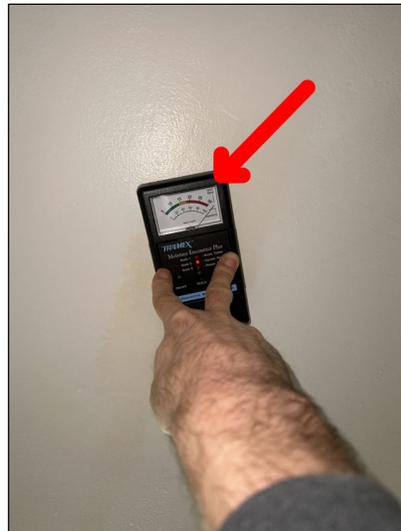
Current moisture detected in the dining room.

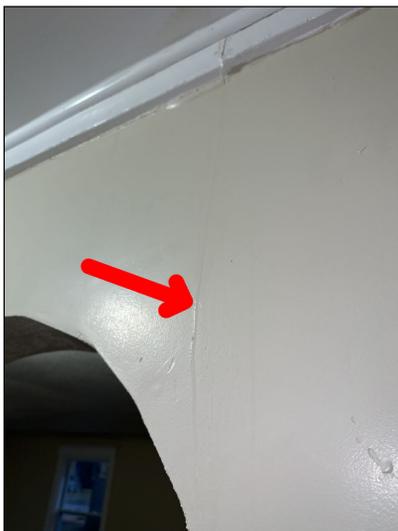
Leaking from the upstairs bathroom.

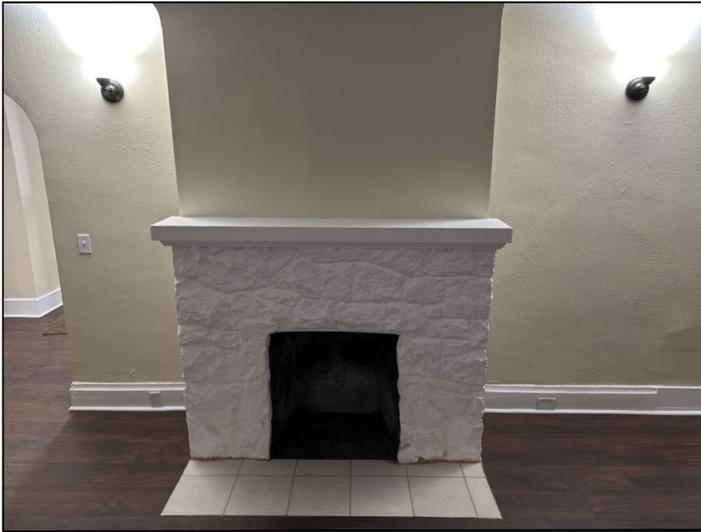
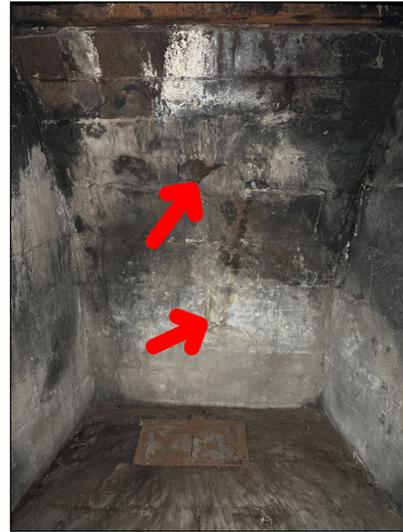
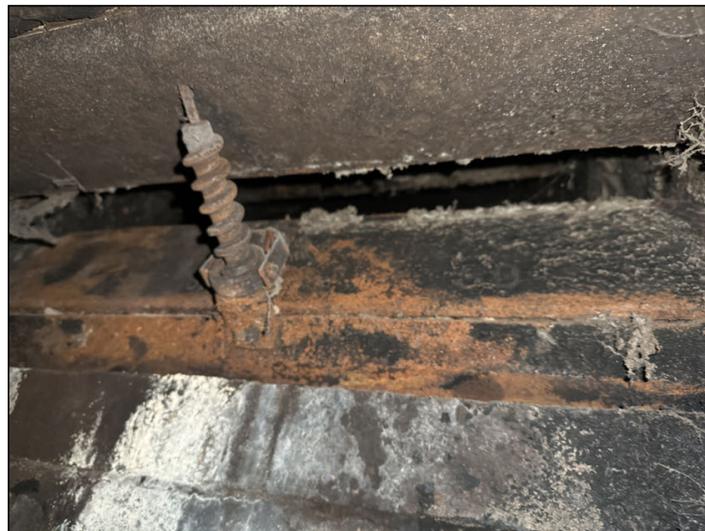
- Damper was opened and closed several times.
- Have a fireplace professional evaluate and repair any issues found before attempting to use fireplace.
- **Deterioration and cracking of the fire bricks noted, recommend repair.**

Deterioration and cracks in the fire bricks

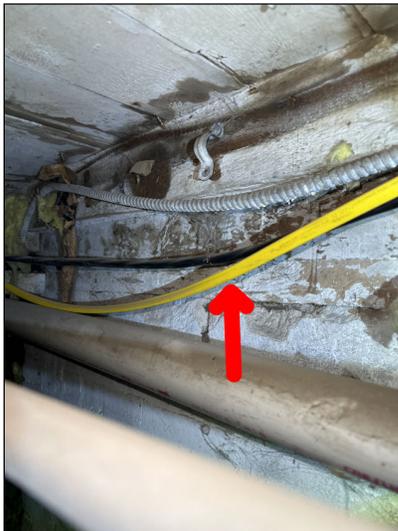
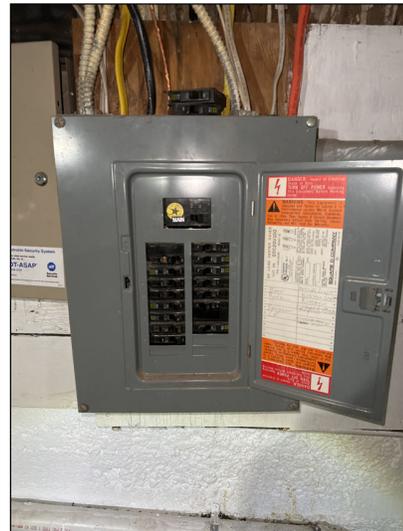
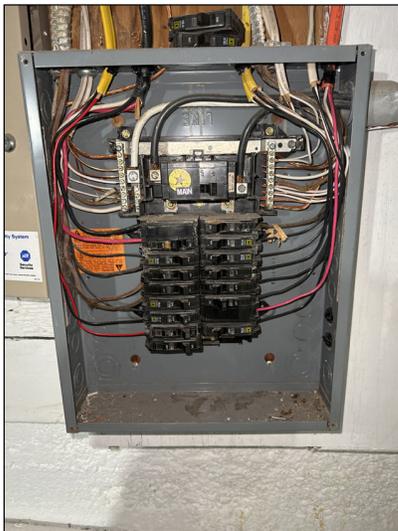
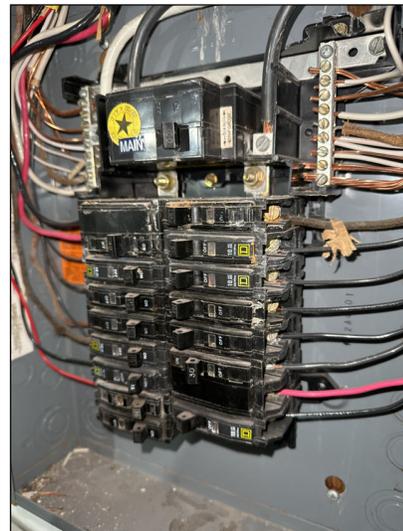
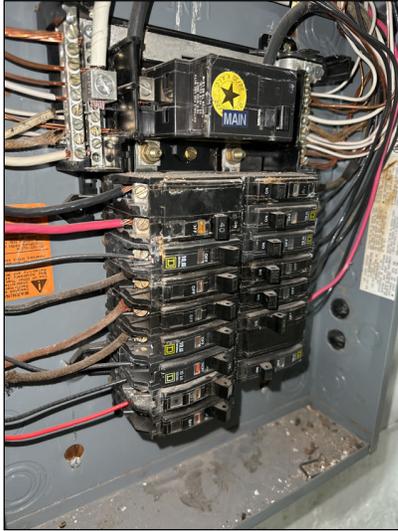
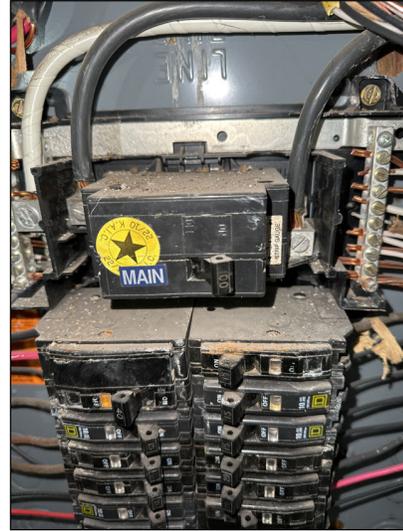
- Panel size appears to be compatible with service size.
- Breaker branch distribution appears to be normal.
- No signs of overheating are evident at the time of inspection.
- **Recommend properly attaching wires to the floor joists for safety.**

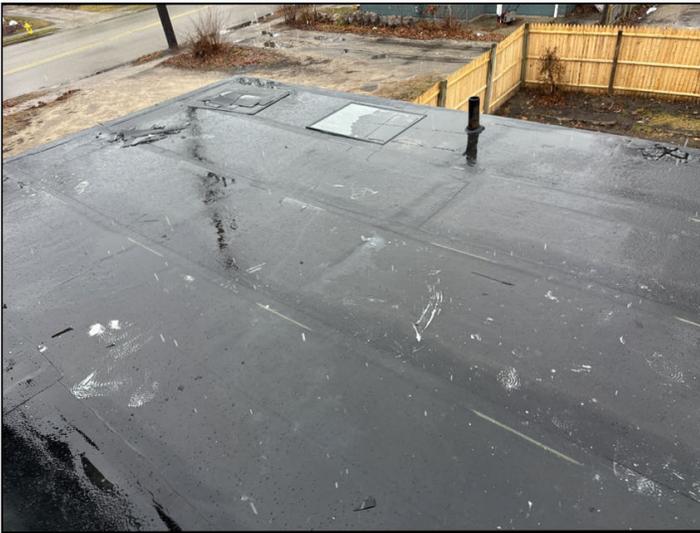
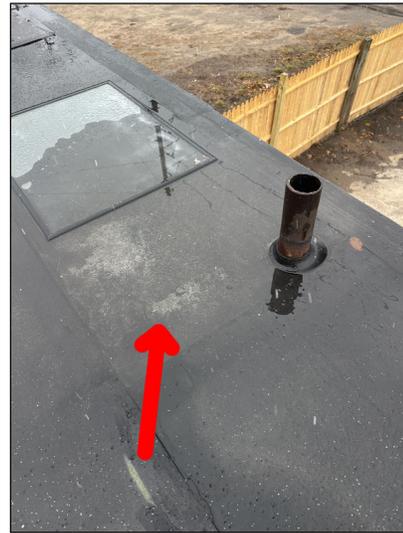
- Recommend monitoring the rolled roof on the rear of the house due to ponding.

Ponding on rolled asphalt roofing in rear on house.

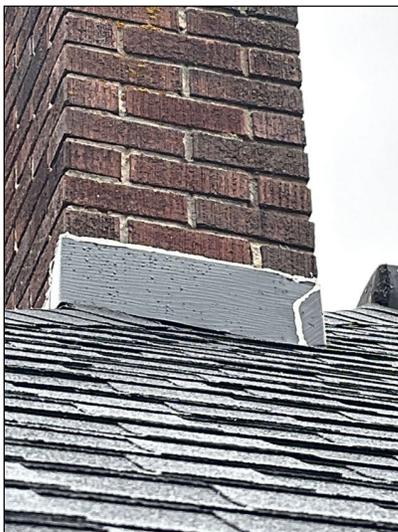
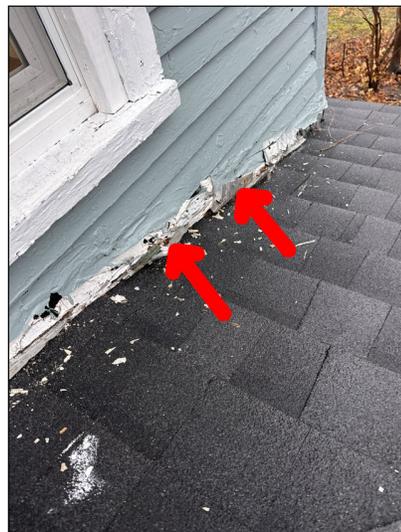
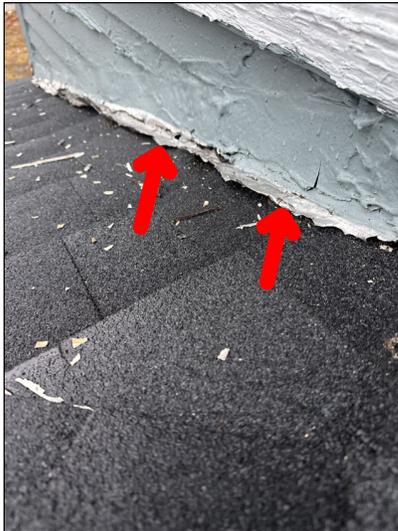
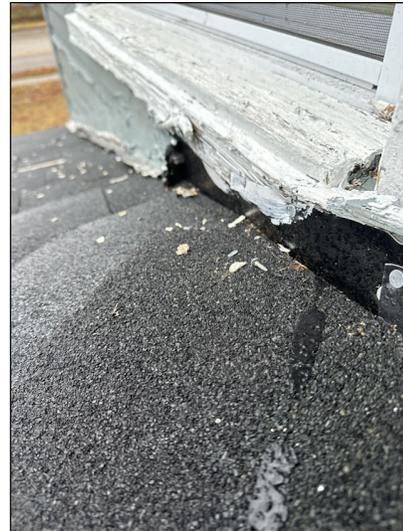
- Recommend repair to the damaged, step flashing and properly sealing.

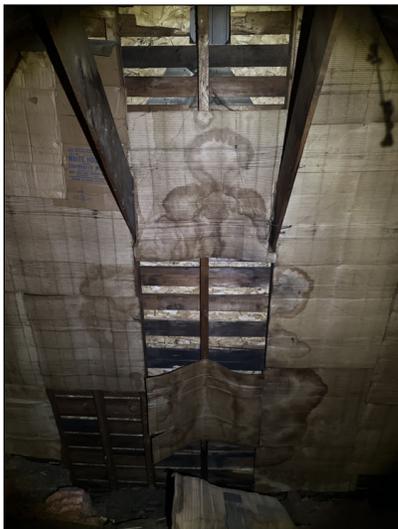
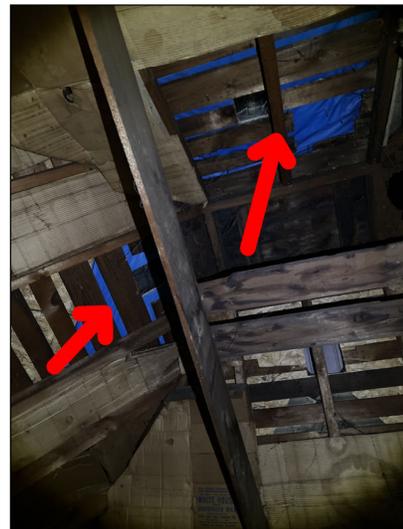
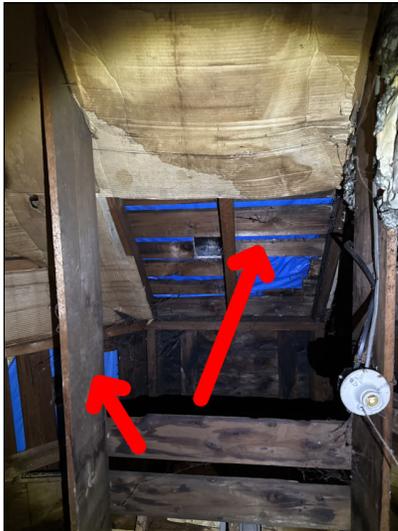
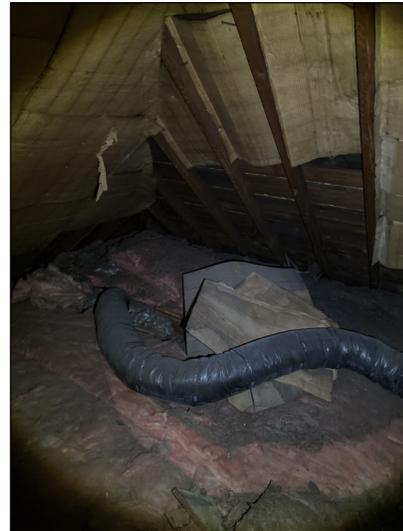
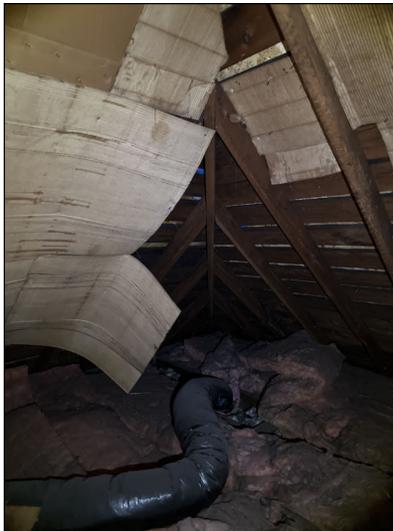
- Plank sheeting present
- OSB sheeting present
- **Most of the structure is covered and not visible. Visible areas show tarp that was left down and possibly used as a vapor barrier, recommend further evaluation/repair.**

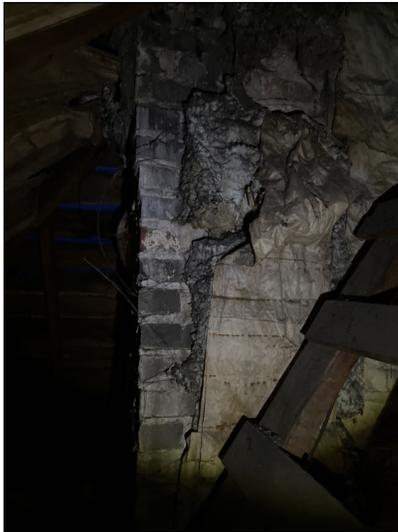
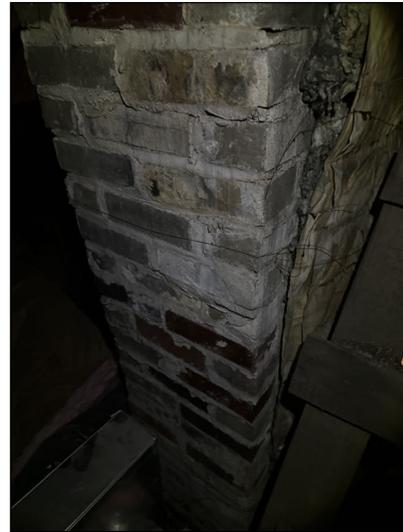
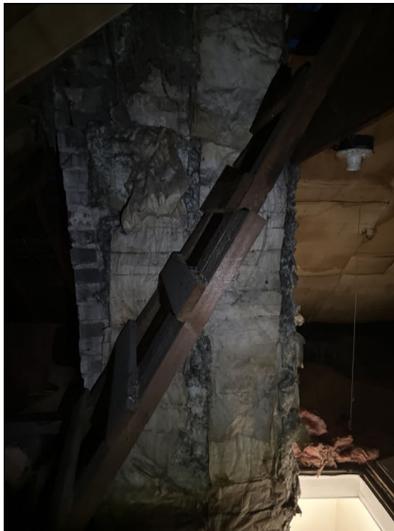
- Most of the chimney is covered by insulation and not visible. visible sections appear to have recent repairs. Recommend monitoring.

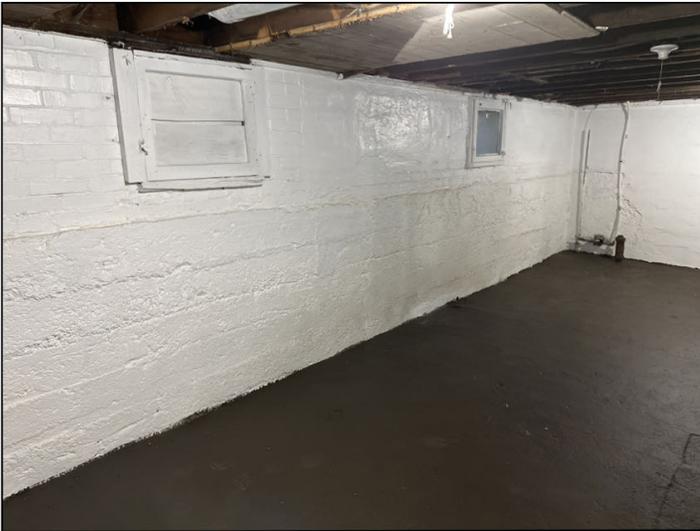
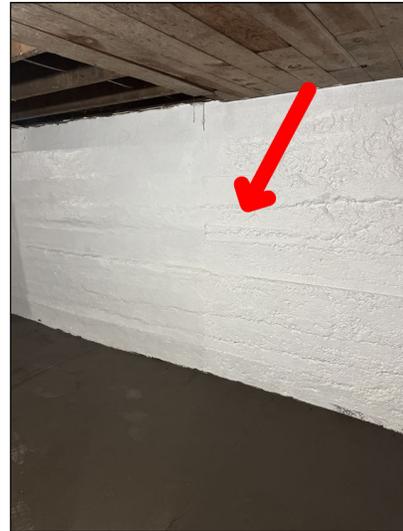
- Foundation walls have been recently painted. Foundation walls have cracking, patching and some movement, recommend monitoring/further evaluation.

East wall shows signs of movement.

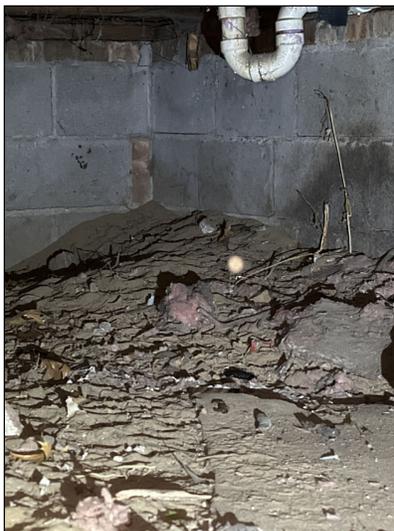
Recommend filling hole between front and rear crawlspace area.

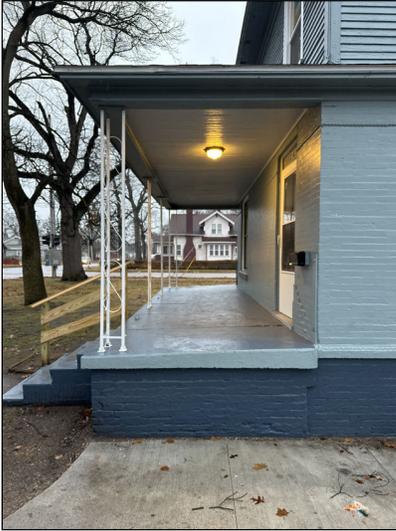
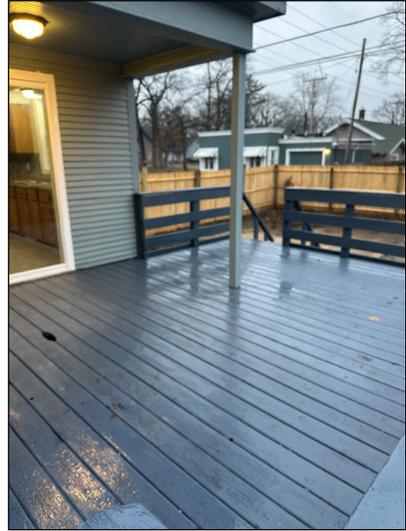
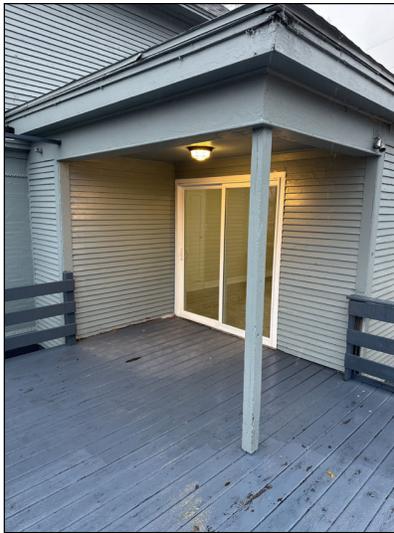
- Porch does have some settling and pitching, recommend monitoring for future movement.

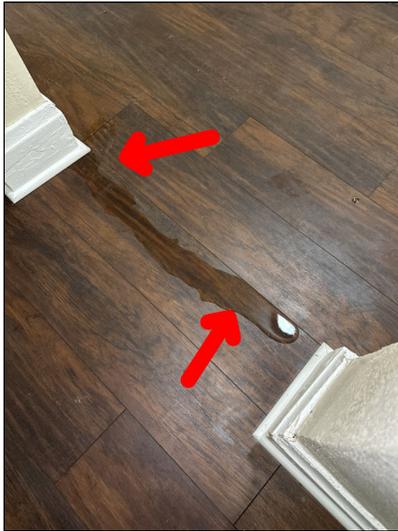
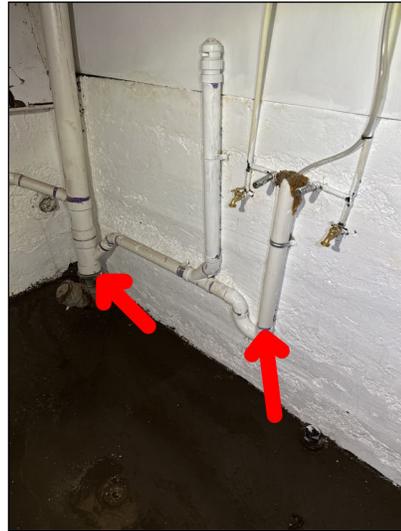
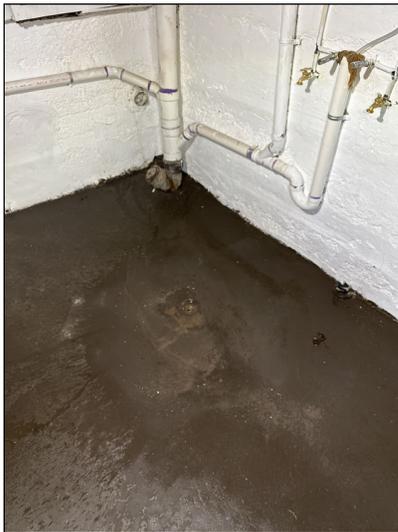
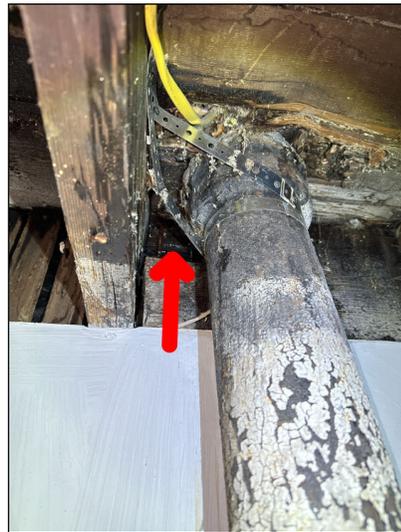
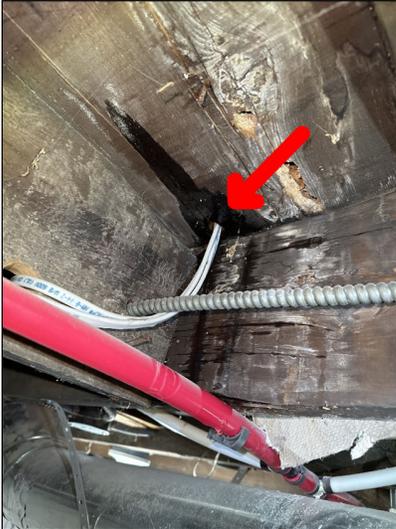
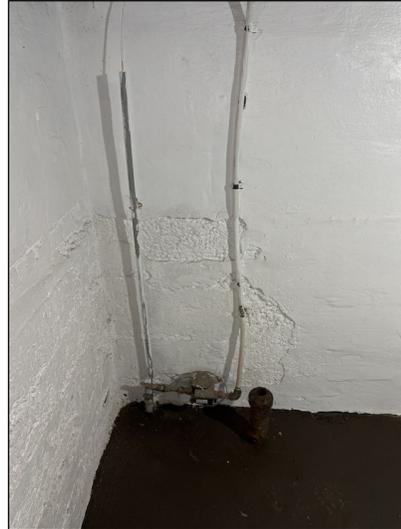
- Cast Iron
- Pex
- **PVC**
- Drain lines are backing up and leaking throughout the home, recommend further evaluation/repair.
- Toilet is leaking behind the wall, recommend further evaluation/repair.

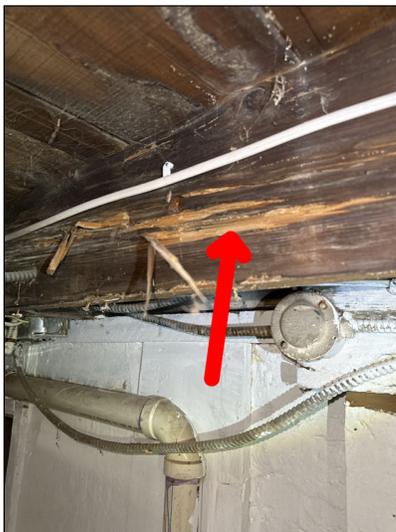
- Recommend further evaluation for the growth on the floor joists.
- Pest damage to the floor joists, recommend further evaluation.

Pest damage to the floor joist, recommend further evaluation/repair.

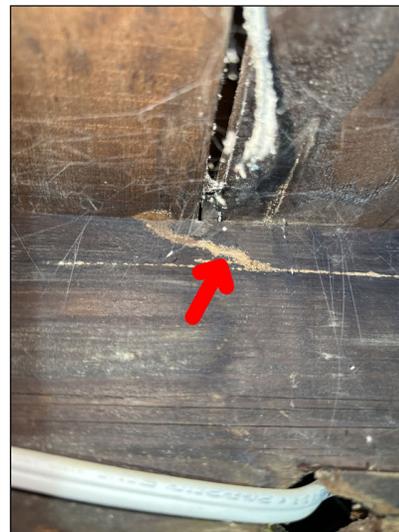
Termite mud tube.

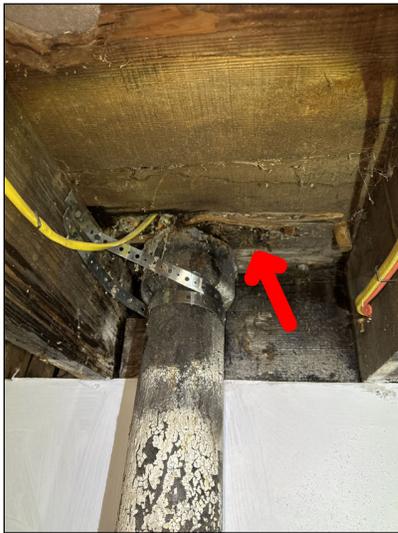
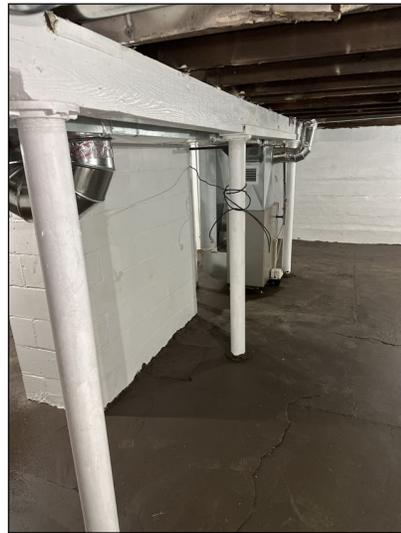
- Visible leaking under bathroom.
- **Some of the Subfloor has deterioration and rotting, recommend repair.**
