Home Inspection Report

1234 Demo Lane , Muskegon , MI 49444

Monday, November 21, 2022

22538

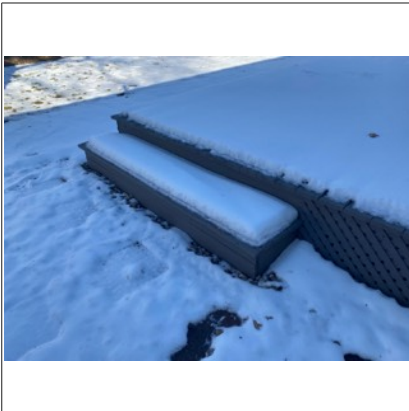
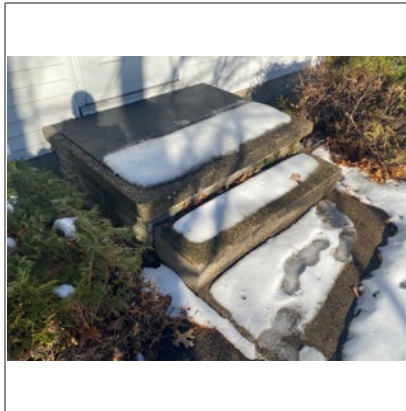
- None
Material Concrete Wood Other: Railing/Balusters recommended
Condition Satisfactory Marginal Poor Safety Hazard Uneven risers Rotted/Damaged
 Cracked Settled
Comments Steps are older and showing normal wear for their age
Photos

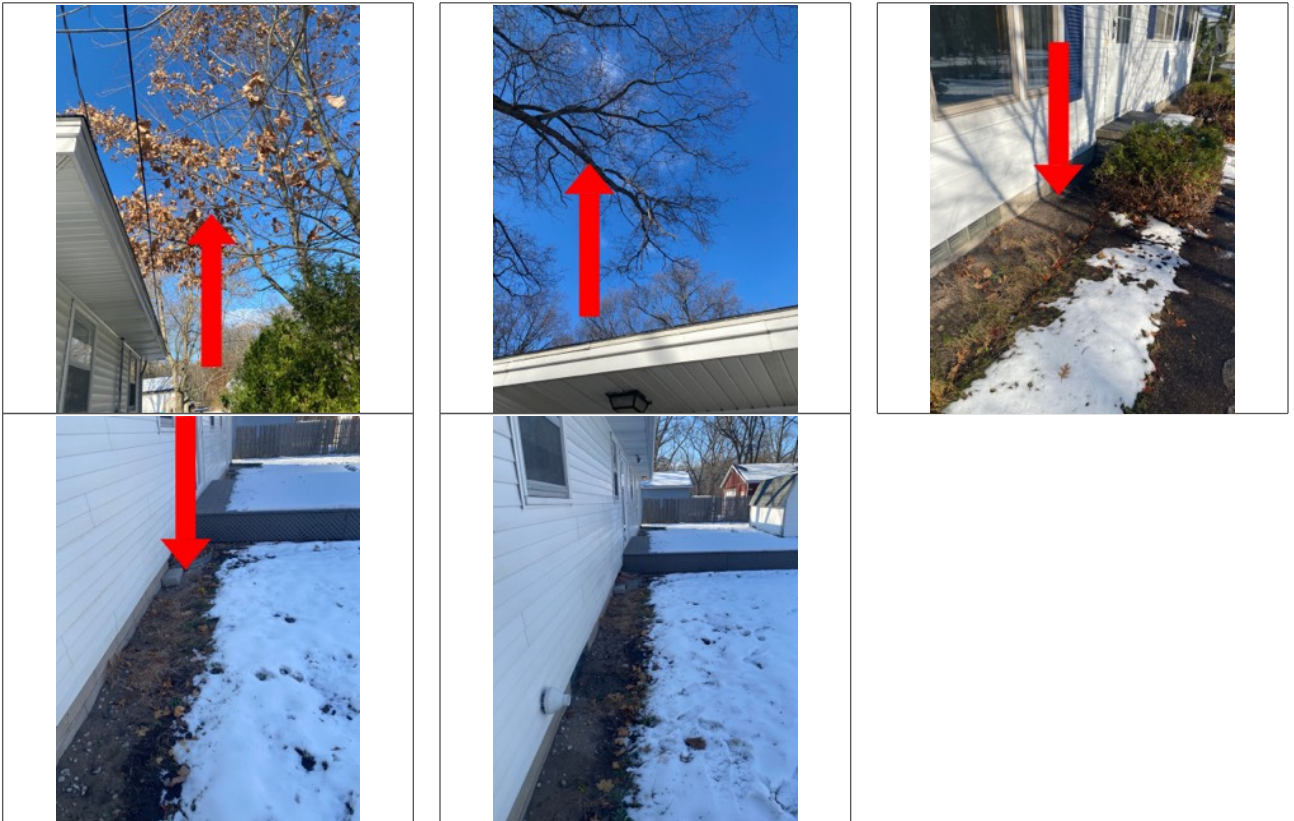
Comments Recommend maintaining a positive drainage slope away from the foundation.
 Low areas of grading next to the foundation recommend adding additional soil and slope away from foundation
 Recommend additional backfill to create a proper pitch away from the house.
 Recommend trimming trees/vegetation so it doesn't come into contact with the home
 Recommend trimming and/or removal of vegetation away from home

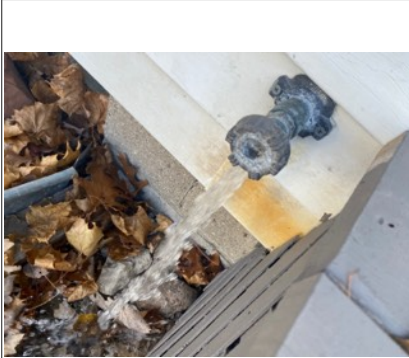
Comments Hose bib(s) not equipped with anti-siphon devices, possible cross connection can occur with anti-siphon device, recommend installing

Recommend removing hoses before winter to prevent freezing.

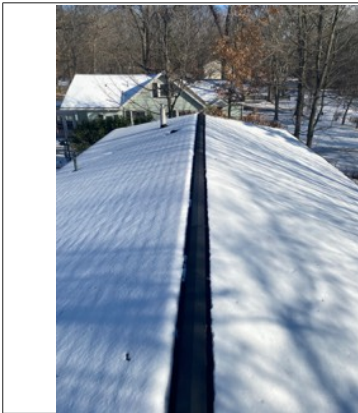
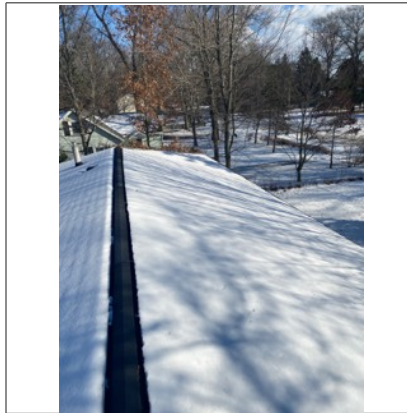
None N/A
 Soffit Ridge Gable Roof Turbine Powered Other: .
Type Adding soffit vents baffles would help provide better airflow to the attic
Comments
Photos

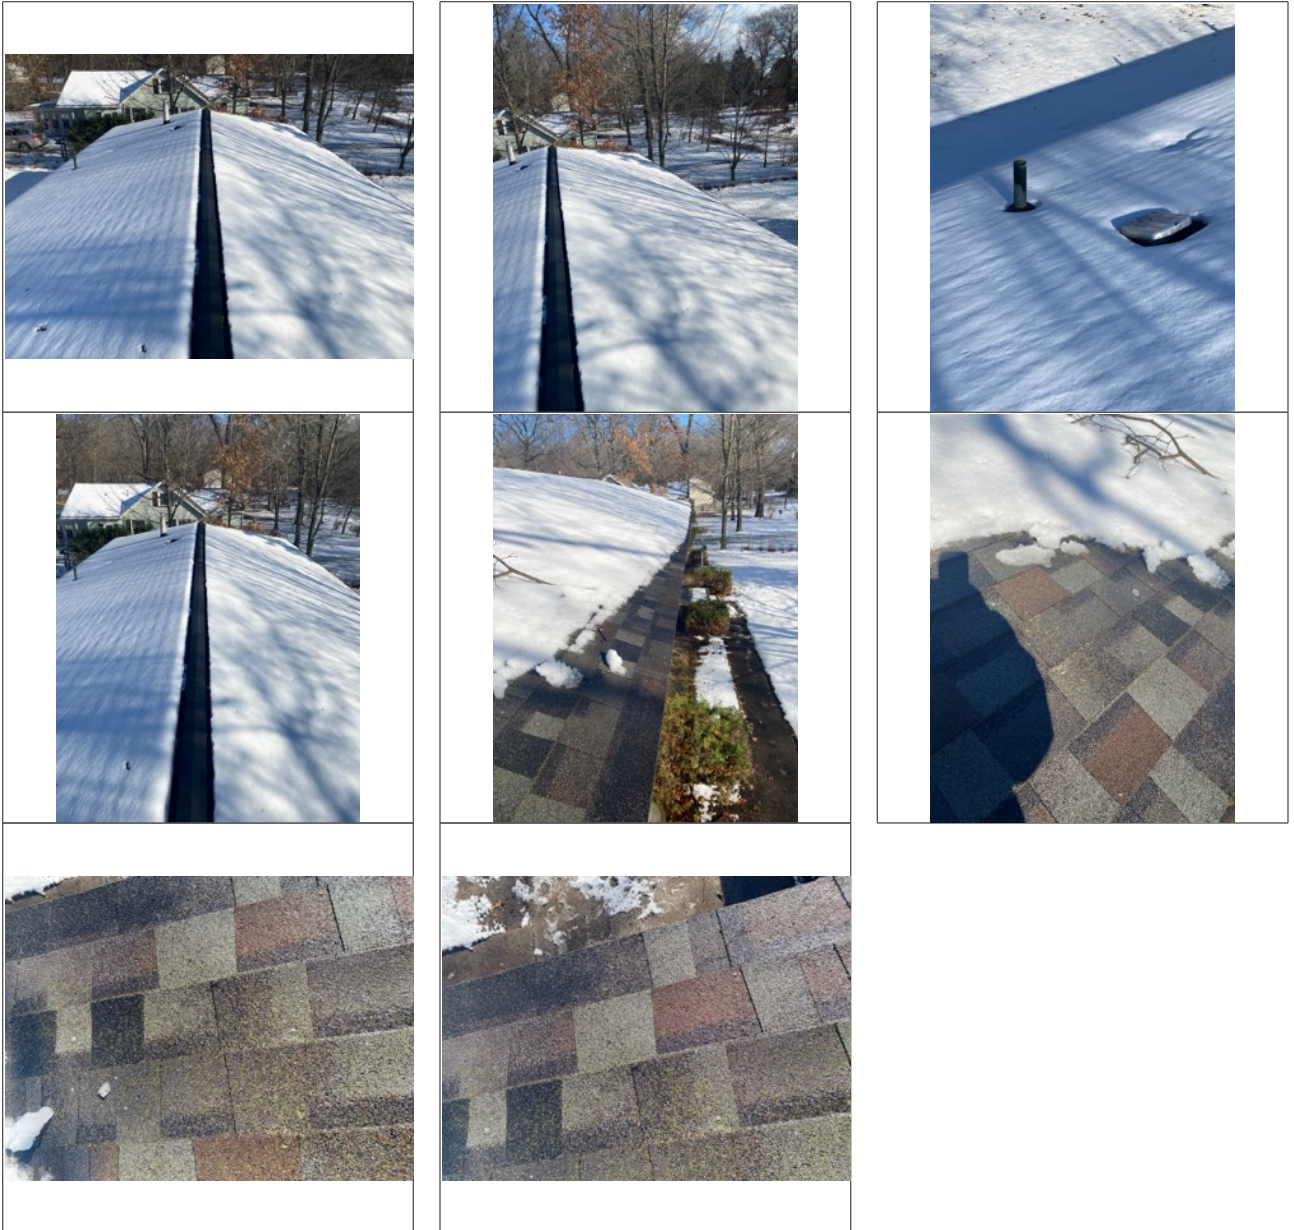
Comments Roof was showing normal wear, but was in overall adequate condition.
 Recommend cleaning moss and mold off of the roof.
 Shingles are rated for 30 years

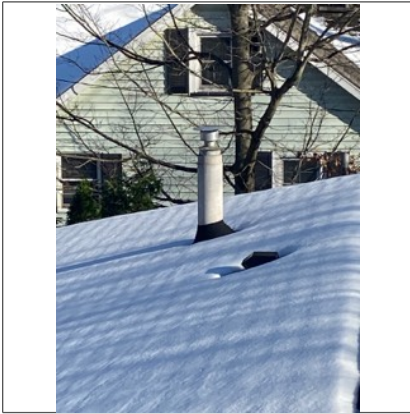
- None
- Location(s)** Northside
- Viewed From** Roof Ladder at eaves Ground (Inspection Limited) With Binoculars
- Rain Cap/Spark Arrestor** Yes No Recommended
- Chase** Brick Stone Metal Blocks Framed
- Evidence of Flue** Holes in metal Cracked chimney cap Loose mortar joints Flaking Loose brick Rust
- Evidence of** Tile Metal Unlined Not Visible
- Condition** Scaling Cracks Creosote Not evaluated Have flue(s) cleaned and re-evaluated
- Comments** Recommend Cricket/Saddle/Flashing
- Photos** Satisfactory Marginal Poor Recommend Repair
- Chimney is showing normal air for its age. Asbestos vent line present. Recommend not disturbing

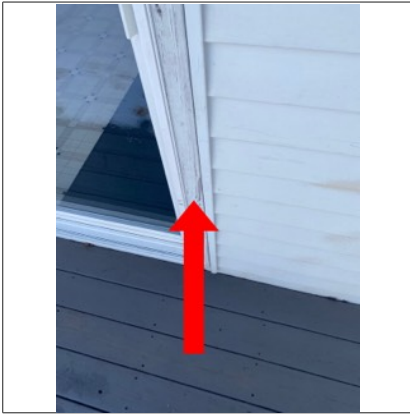
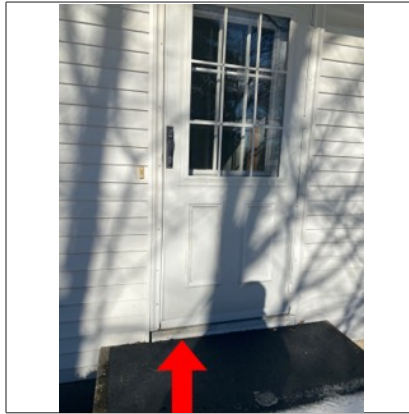
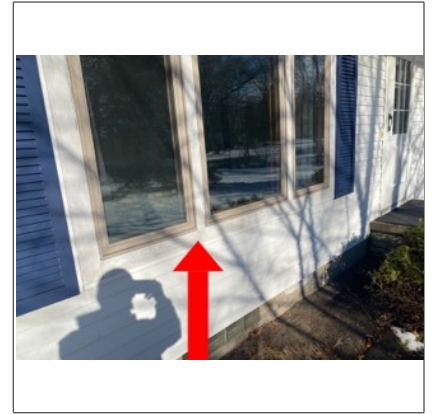
- Material** Wood Fiberboard Aluminum/Steel Vinyl Stucco Recommend repair/painting
- Damaged wood Other: .
- Condition** Satisfactory Marginal Poor
- Comments** Trim was in need of normal painting maintenance.

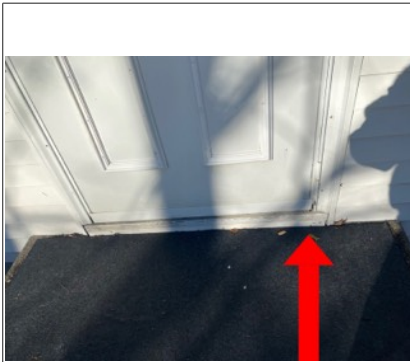
Recommend resealing around exterior doors to help prevent moisture intrusion

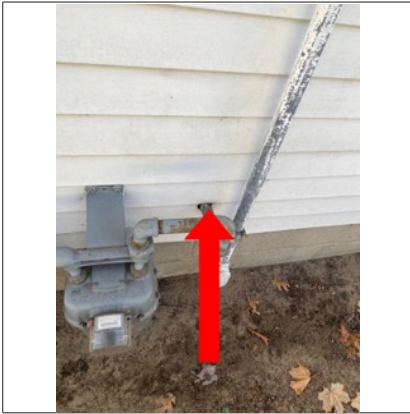
Condition None Satisfactory Marginal Poor
 Recommend around windows/doors/masonry ledges/corners/utility penetrations
Comments Recommend caulking around windows, doors, corners, utility penetrations.

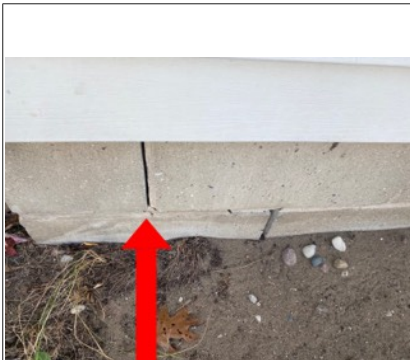
Comments Recommend keeping water diverted away from the structure to help prevent future movement. Recommend monitoring

Recommend Tuckpointing missing mortar joints

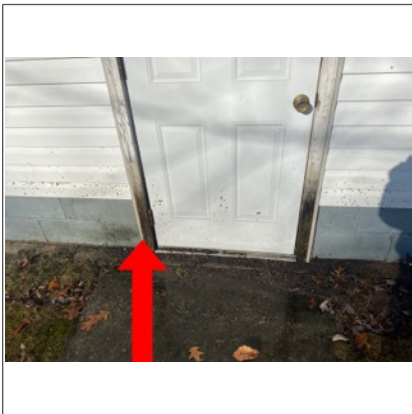
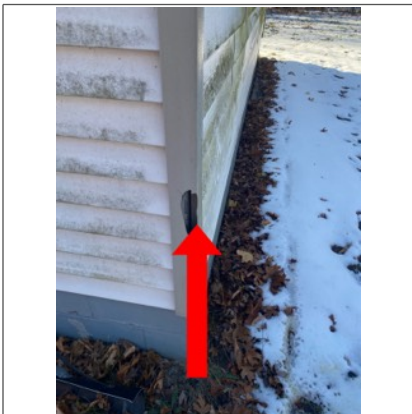
N/A
 Same as house Wood Aluminum Vinyl
 Satisfactory Marginal Poor Recommend repair/replace Recommend painting
Comments Trim had some damage recommend repair
Photos

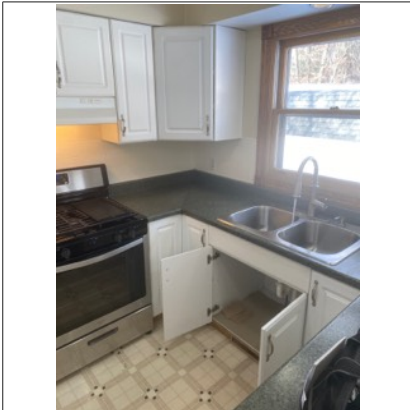
Comments Cabinets have normal wear.

Recommend hinges be tightened.

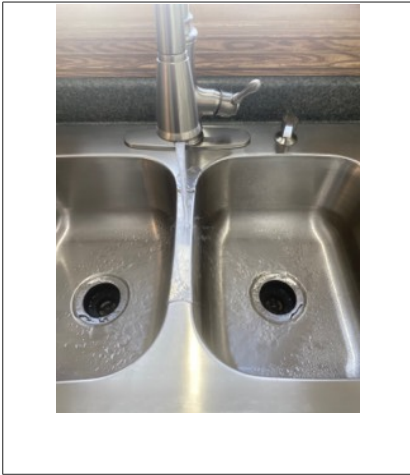
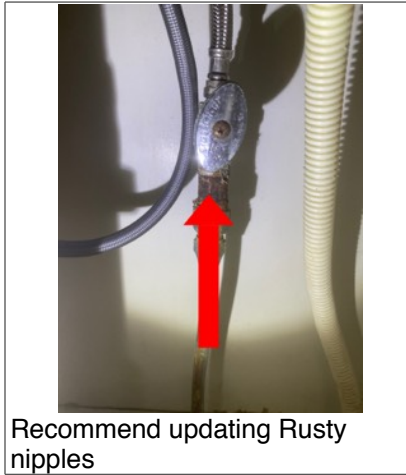
Drain lines had no visible leaks or signs of backup at the time of inspection.

Recommend updating Rusty nipples

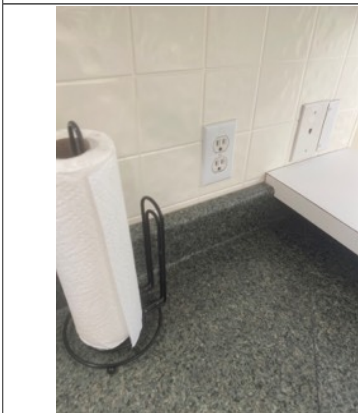
Recommend outlets around the sink be ground fault protected

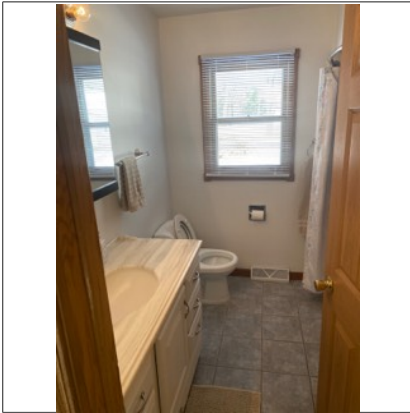
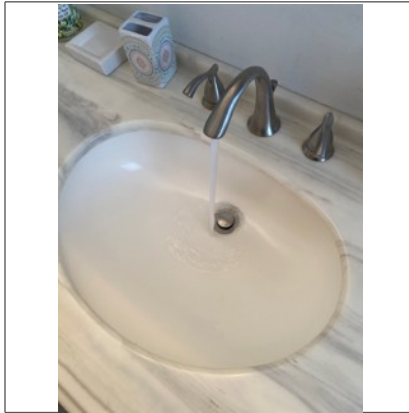
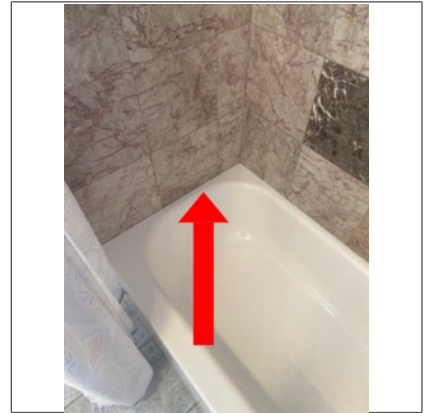
Comments Drain lines are functioning correctly. Great water pressure.
 Recommend caulking/grouting in shower/tub area
 Loose window lock

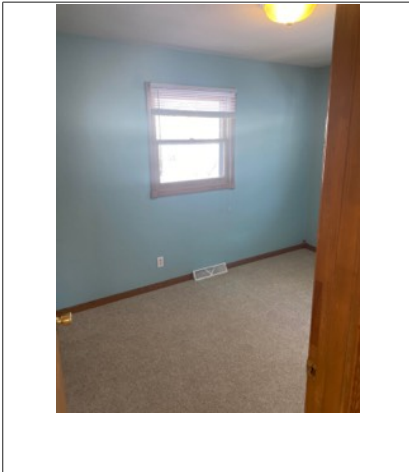
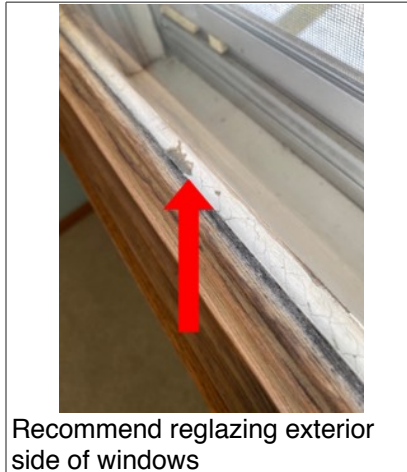
Comments Recommend smoke detector

Recommend reglazing exterior side of windows

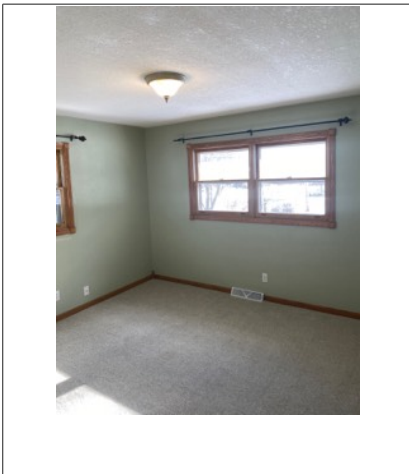
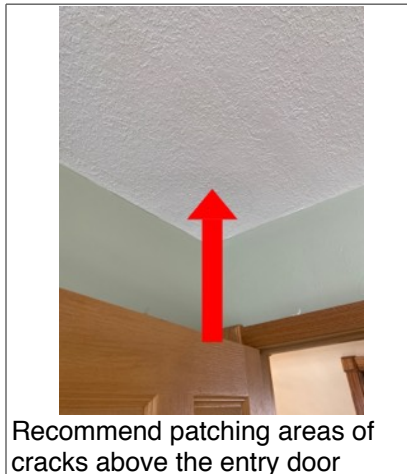
Recommend patching areas of cracks above the entry door

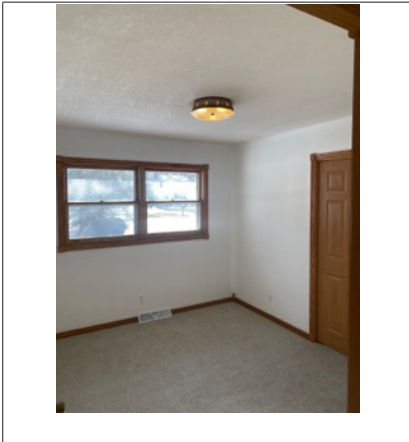
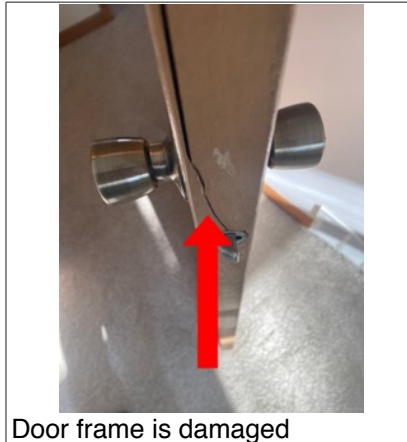
Comments Recommend patching stress cracks in the ceiling

Door frame is damaged

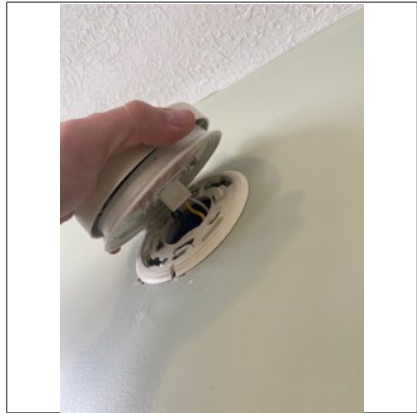
Comments Smoke detectors are hardwired. Recommend additional for North bedroom. Recommend updating due to age. Recommend carbon monoxide detector

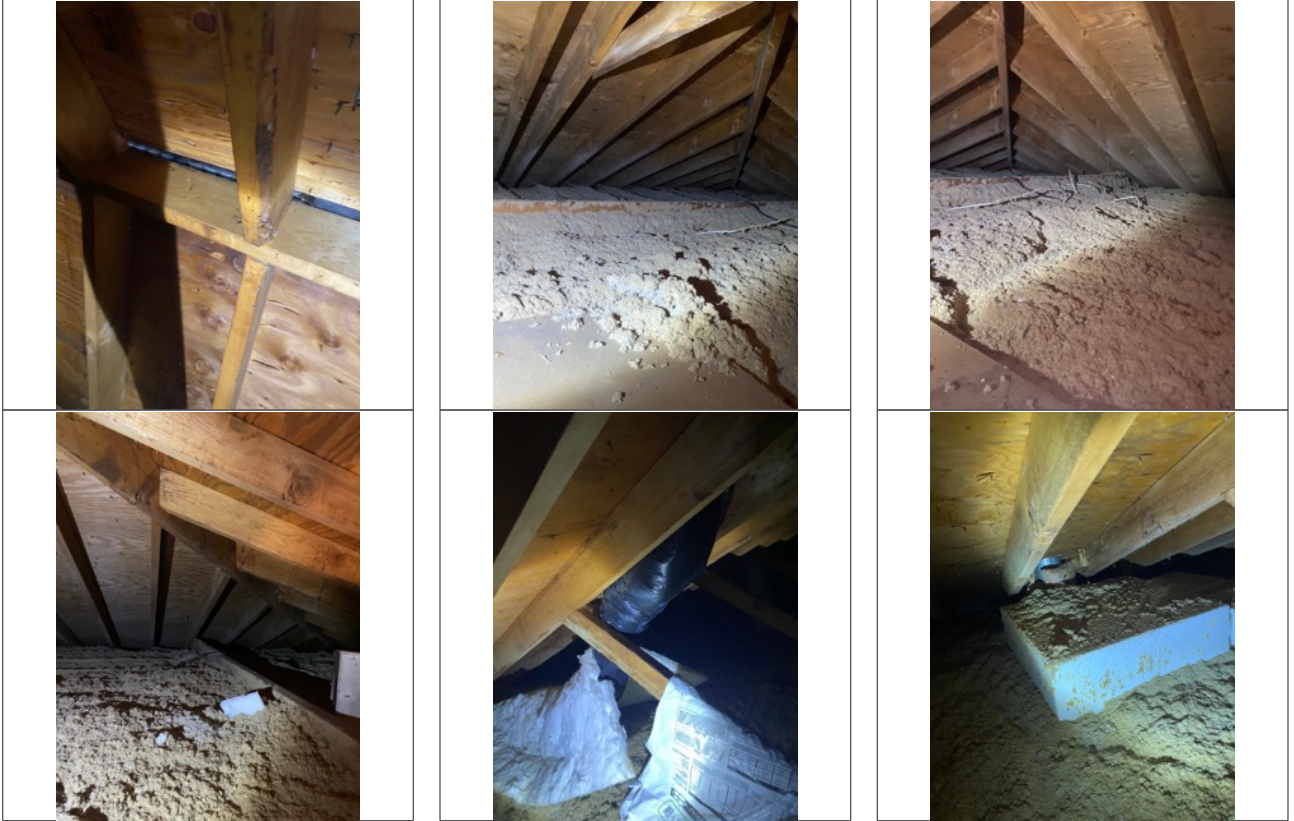
Comments Recommend proper weatherstripping be installed around attic access

Ventilation was marginal recommend additional ventilation be added

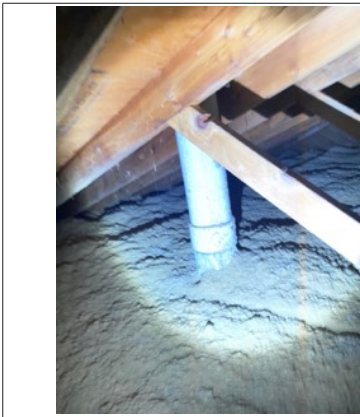
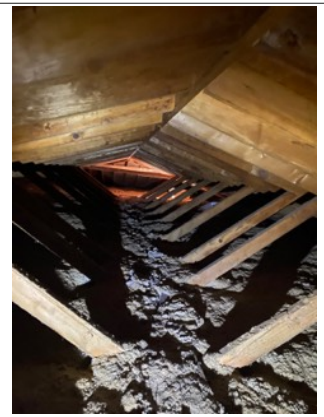
Asbestos beltline. Recommend not disturbing

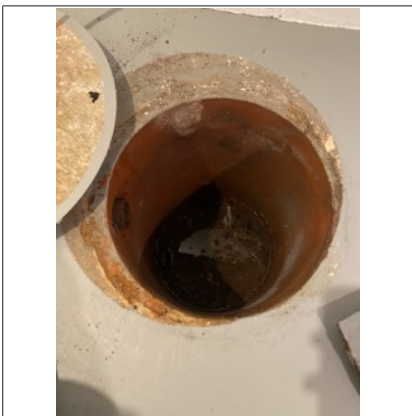
Sump pump Yes No Working Not working Needs cleaning Pump not tested
Floor drains Yes Not Visible Drains not tested
Comments No active seepage visible at the time of the inspection.

If water table rises, recommend installing sump pump

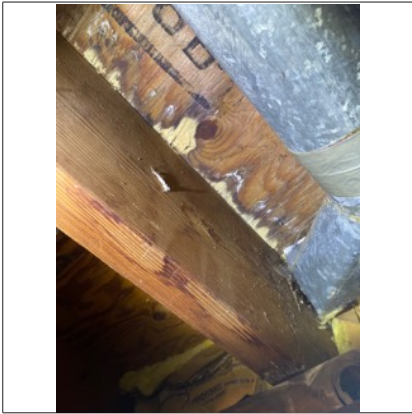
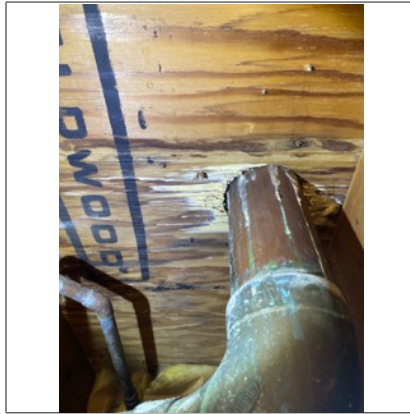
Condition Not Visible Satisfactory Marginal Poor Indication of moisture stains/rotting
Comments Dry stains and growth underneath the bathroom. Recommend repair

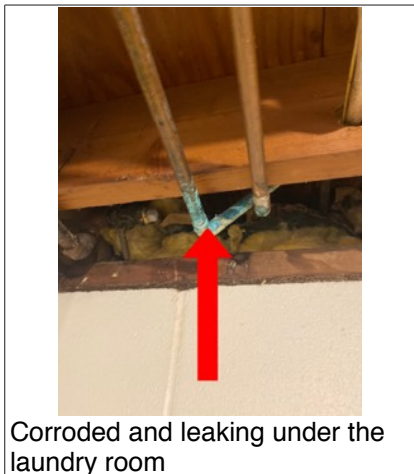
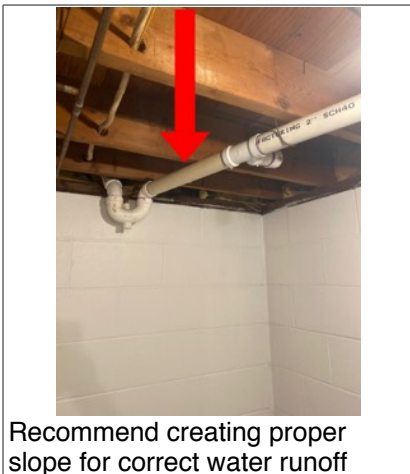
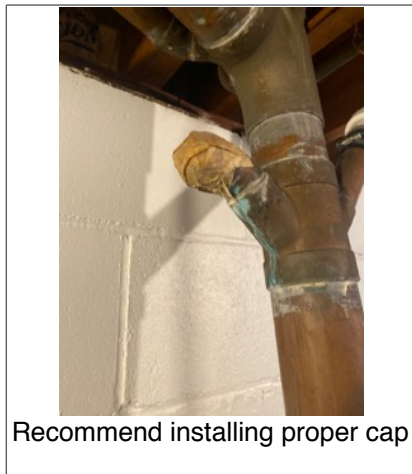
Comments Water pressure in the home was overall good. Drain lines are functioning correctly at the time of the inspection. Recommend repair to areas of rust and corrosion. Recommend creating proper slope for drain lines.

Negative slope in the drain line

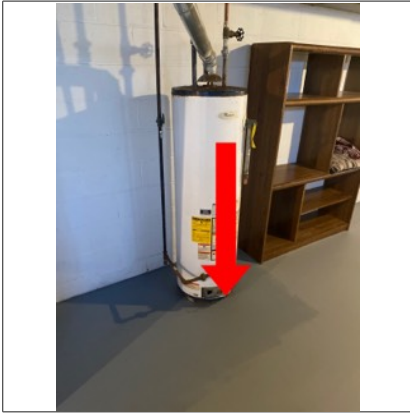
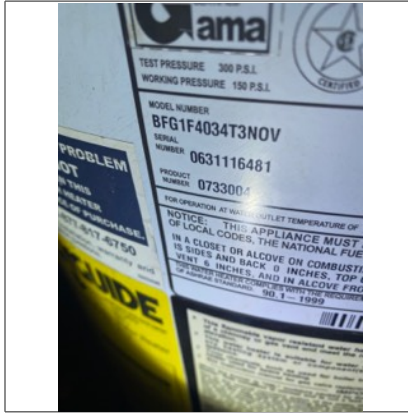
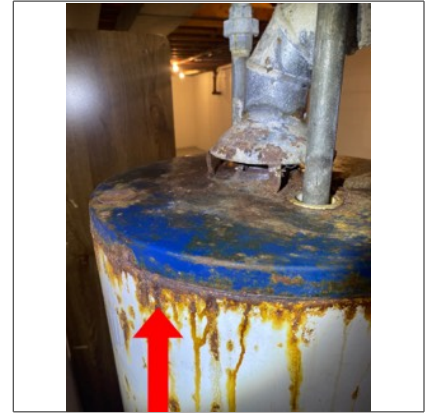
Comments Water heater is functioning but the tank is heavily rusted and damaged. Recommend updating soon

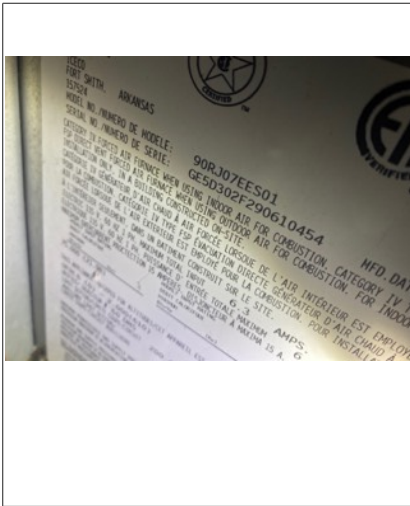
Condensation is dripping from the vent line. Recommend repair in resealing around this joint

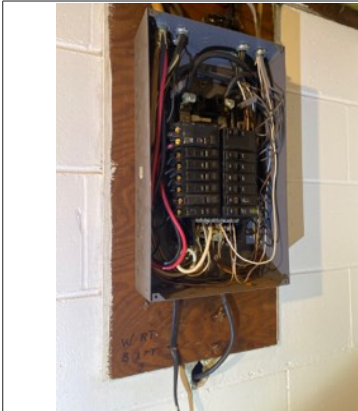
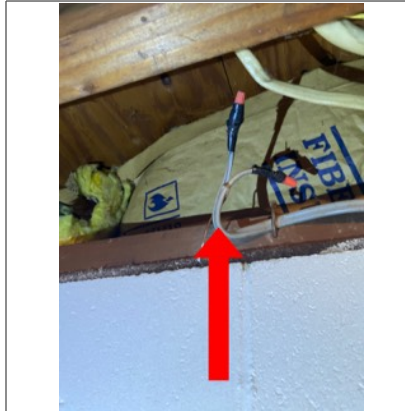
Comments
Panel size appeared to be compatible to service size.
Panel was full and may need to be upgraded for future needs.
Handy man wiring present - recommend a licensed electrician evaluate, repair and replace as necessary.
No signs of overheating were evident at the time of the inspection.
Recommend panel be properly labeled

Recommend removing wire that is no longer used. Double tapped into pre-existing breaker
