Home Inspection Report

1234 Demo Lane , Muskegon , MI 49444

Monday, November 21, 2022

22538

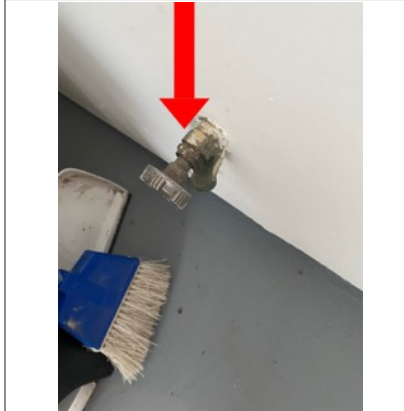
Handle is stuck on the hose Spicket in the garage

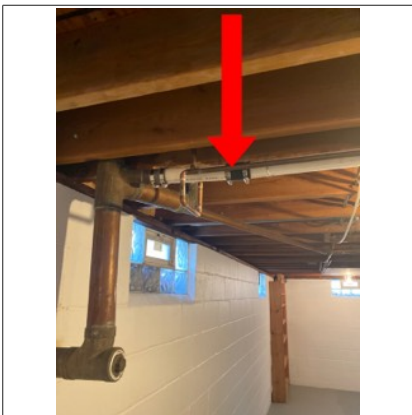
Negative slope in the drain line

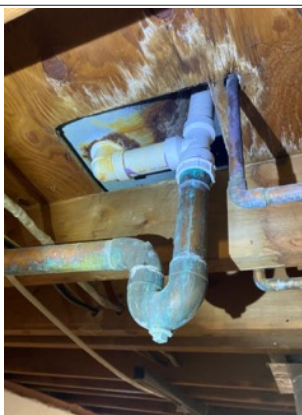
Recommend monitoring or updating Rusted plumbing underneath the bathroom

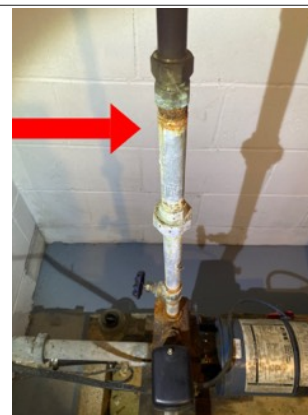
Recommend updating rusted nipples

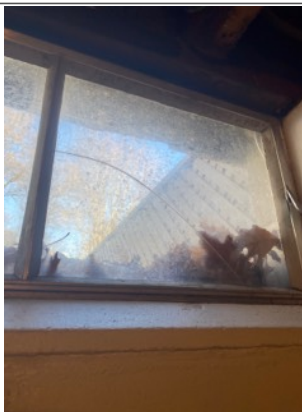
Cracked basement window
