Stone River Home Inspections

Property Inspection Report

4242 Aztec Lane, muskegon , MI 49442
Inspection prepared for: John Doe
Date of Inspection: 1/5/2023 Time: 8:00 A.M.
Age of Home: 1925 Size: 1,942 Sqft
Weather: Snow 35 degrees

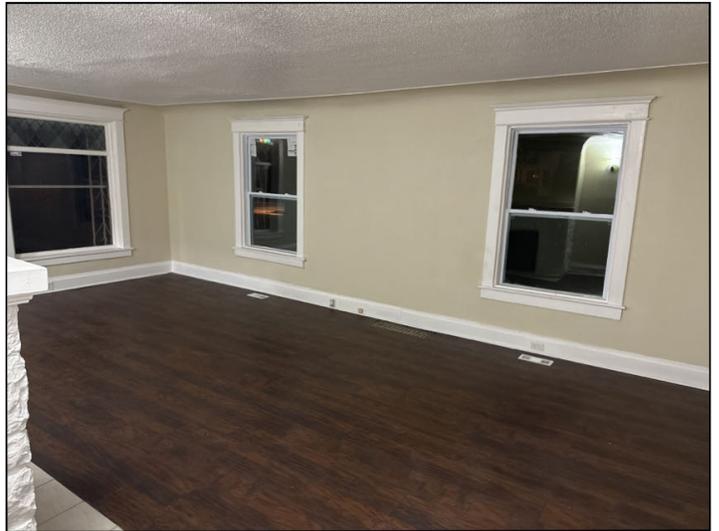
Living room.

- Moisture stains present
- **Upstairs bathroom is leaking through the floor and down the ceiling and wall of the living room/dining room area, recommend further evaluation/repair.**

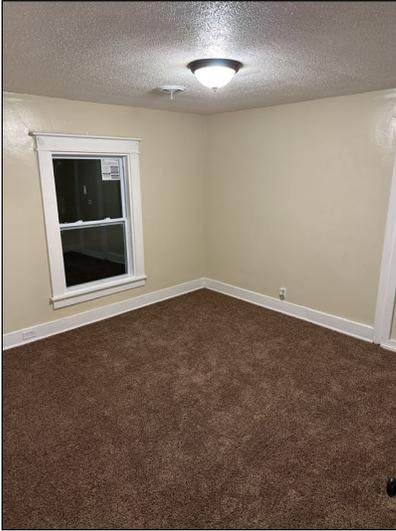
West bedroom.

- Typical cracking.

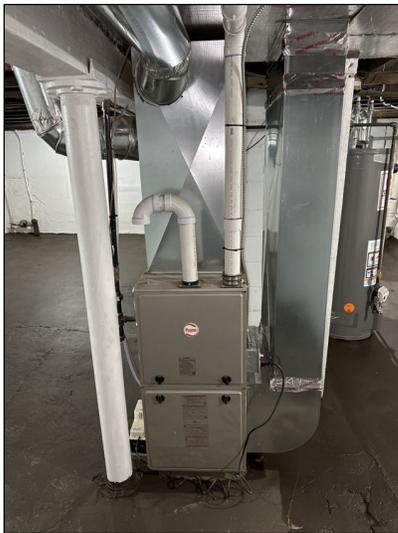
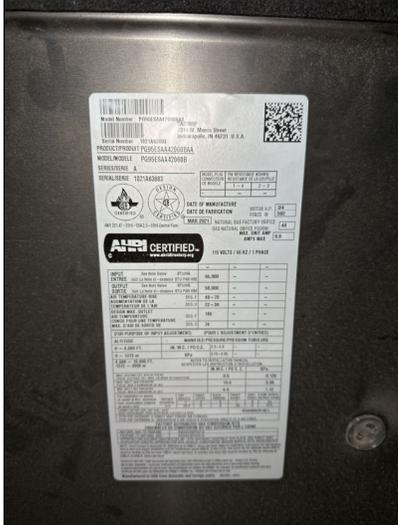
- Furnace is operating properly at the time of inspection.

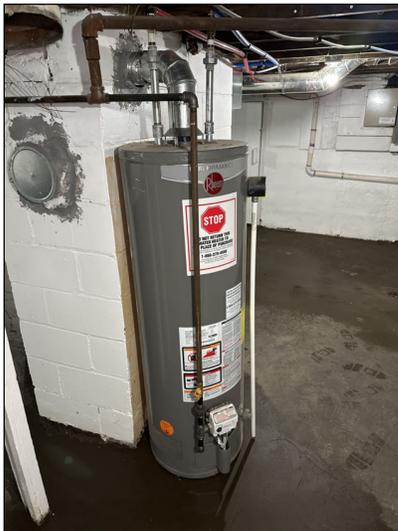
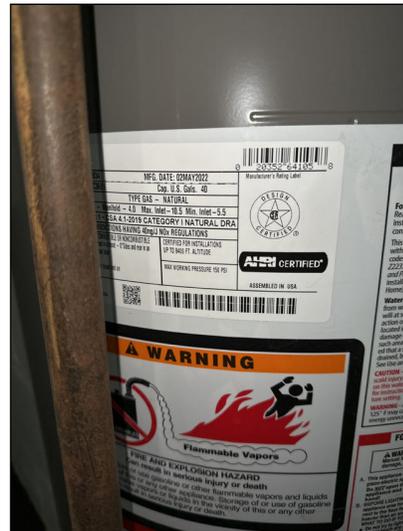
Rheem
2022

- Tank appears to be in satisfactory condition -- no concerns.

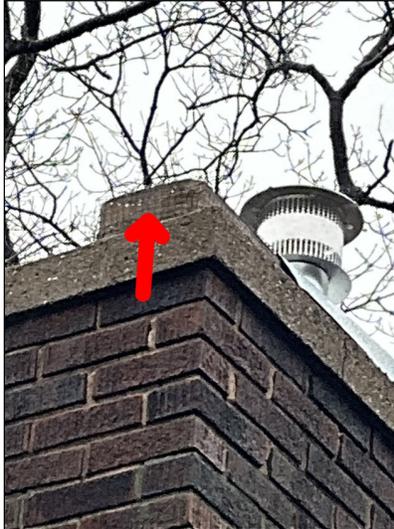
- Rain/spark cap is present.
- **Wire mesh only is installed as a spark arrester, this is considered to be inadequate and a proper spark arrester should be installed.**

Wire mesh.

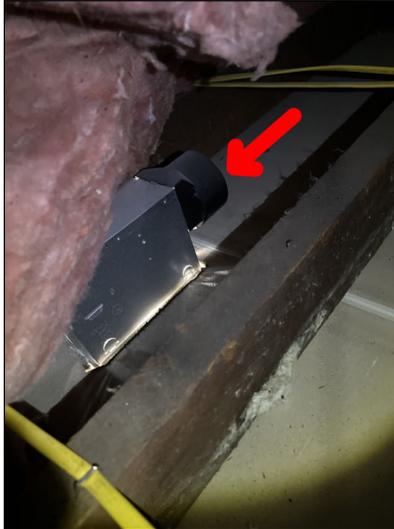
- Exhaust fan duct appears to terminate in attic. Have duct routed to exterior to minimize moisture an possible development of mold.

Bathroom exhaust fan.

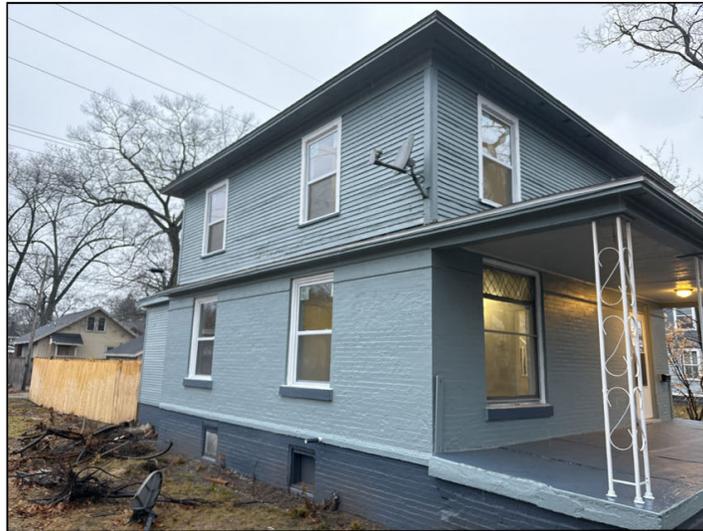
3. Siding Condition

Materials: Brick veneer noted. • Painted wood siding

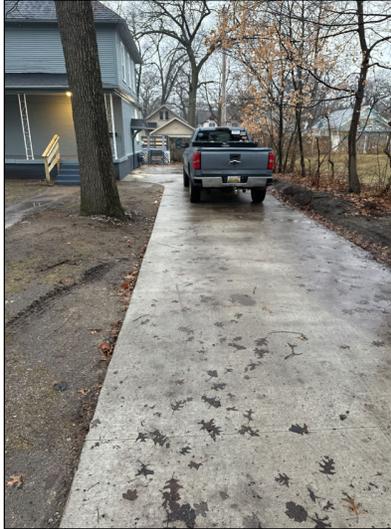
1. Driveway and Walkway Condition

- Driveway in good shape for age and wear. No deficiencies noted.

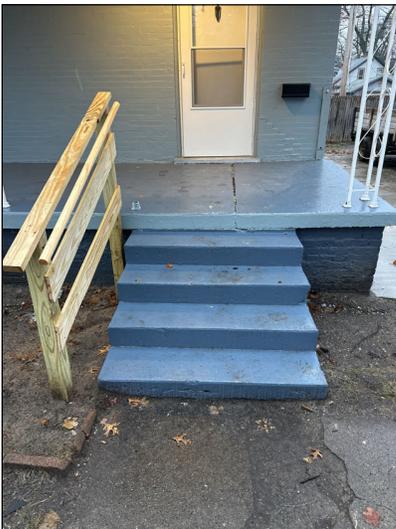
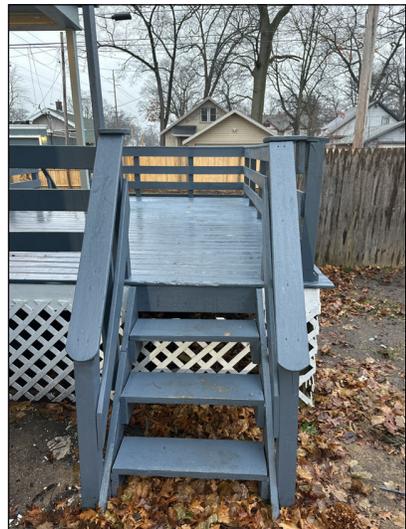
- Appeared functional at time of inspection.

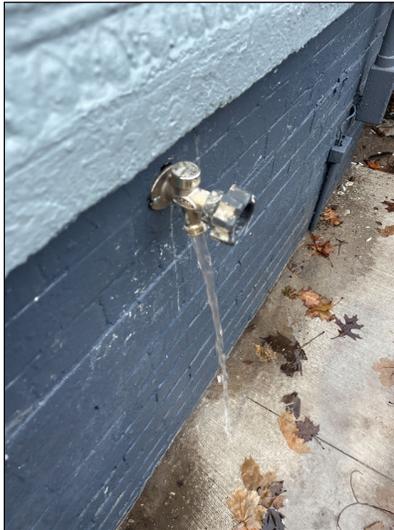
7. Exterior Faucet Condition

- Appears Functional.
- Recommend removing hoses before winter.

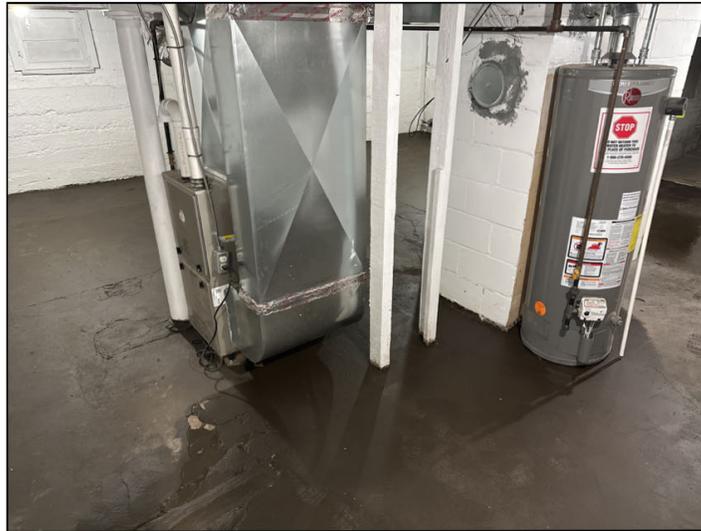
- Common cracks noted.

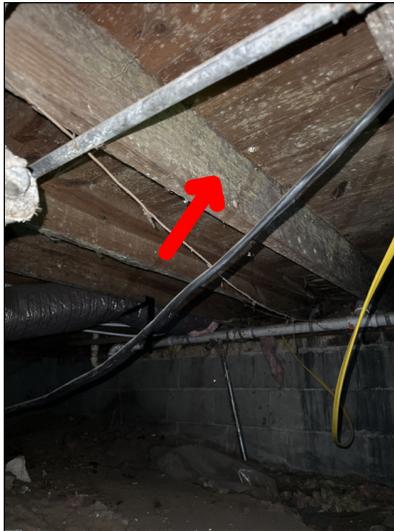
- Recommend further evaluation for the growth on the floor joists.
- Pest damage to the floor joists, recommend further evaluation.

Growth on floor joists.
