Home Inspection Report

1234 Demo Lane , Muskegon , MI 49444

Monday, November 21, 2022

22538

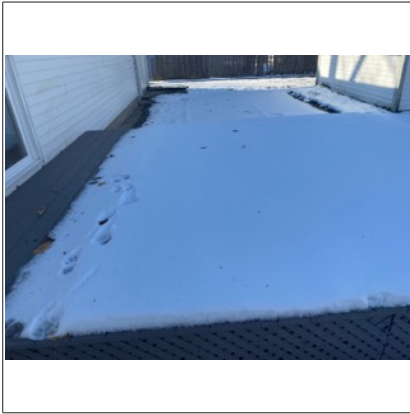
- None Not Visible
Material Wood Metal Composite Railing/Balusters recommended
Condition Satisfactory Marginal Poor Wood in contact with soil
Finish Treated Painted/Stained Other: _____ Safety Hazard Improper attachment to house
 Railing loose
Comments Deck where visible appears to be in overall good condition

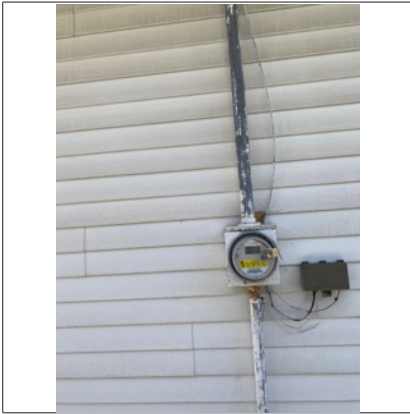
Comments Properly attached to the structure

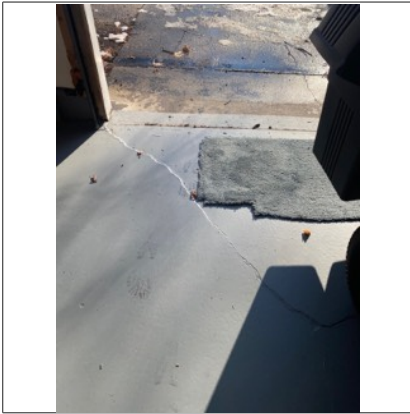
Concrete Gravel Asphalt Dirt Other: .
 Satisfactory Typical cracks Large settling cracks Recommend evaluation/repair
 Safety hazard
Source of Ignition within 18" of the floor N/A Yes No
Comments The foundation is overall adequate with no major defects evident.

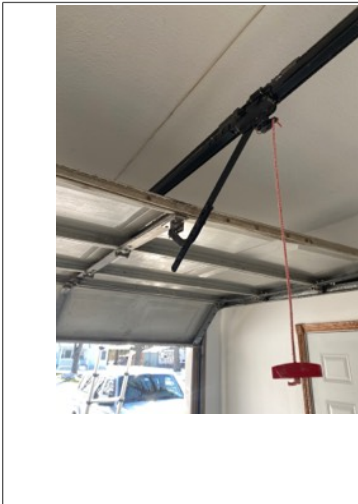
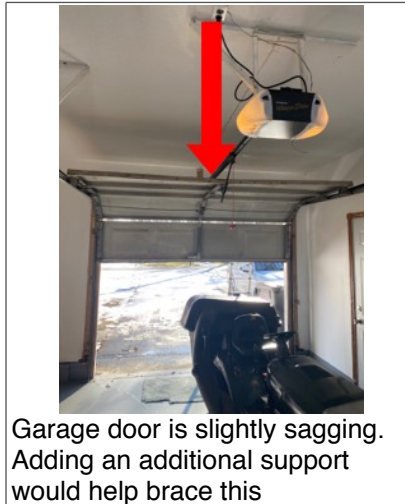
N/A
Material Wood Fiberglass Masonite Metal Recommend repair
Condition Satisfactory Marginal Poor Hardware loose Safety Cable Recommended
 Weatherstripping missing/damaged Loose/missing
Recommend Priming/Painting Inside & Edges Yes No
Comments Garage door and opener was in normal working order.

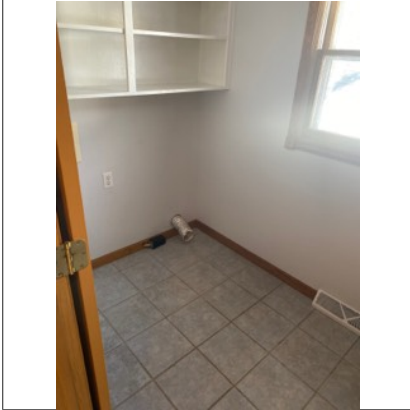
- Laundry sink** N/A
Faucet leaks Yes No
Pipes leak Yes No Not Visible
Cross connections Yes No Potential Safety Hazard
Heat source present Yes No
Room vented Yes No
Dryer vented N/A Wall Ceiling Floor Not vented Plastic dryer vent not recommended
 Not vented to exterior Recommend repair Safety hazard
Electrical Open ground/reverse polarity: Yes No Safety hazard
GFCI present Yes No Operable: Yes No Recommend GFCI Receptacles
Appliances Washer Dryer Water heater Furnace/Boiler
Washer hook-up lines/valves Satisfactory Leaking Corroded Not Visible
Gas shut-off valve N/A Yes No Cap Needed Safety hazard Not Visible
Comments Electric option for dryer. Recommend ground fault outlet

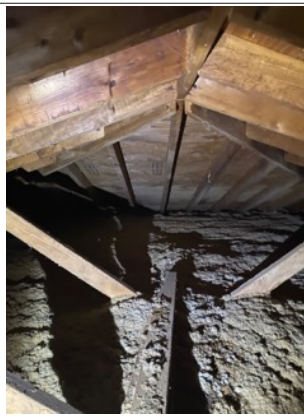
Asbestos beltline. Recommend not disturbing

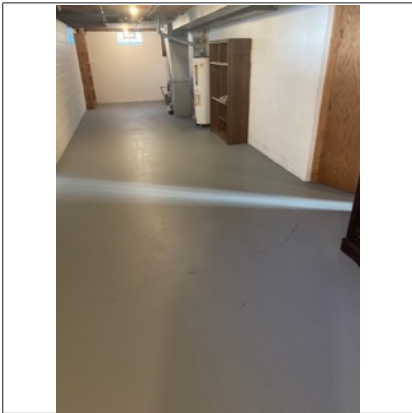
Material Concrete Dirt/Gravel Not Visible Other: .
Condition Satisfactory Marginal Poor Typical cracks Not Visible
Comments Floor appeared to be in overall satisfactory condition.
 Floor had typical cracks.

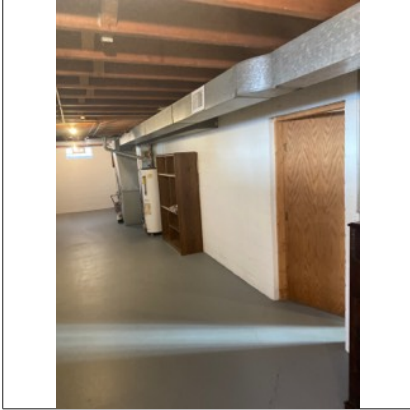
Material Steel Wood Concrete LVL Not Visible
Comments Main supports are in tact and properly supporting the structure
Photos

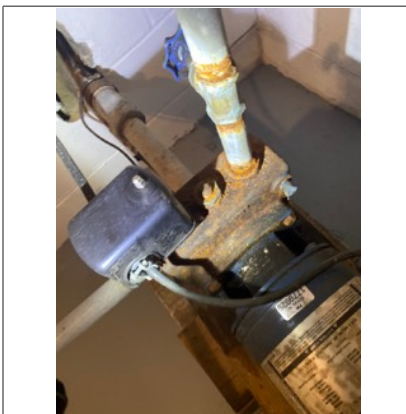
Comments Well pump is functioning at the time of the inspection. Recommend completing Well And Septic evaluation for further information

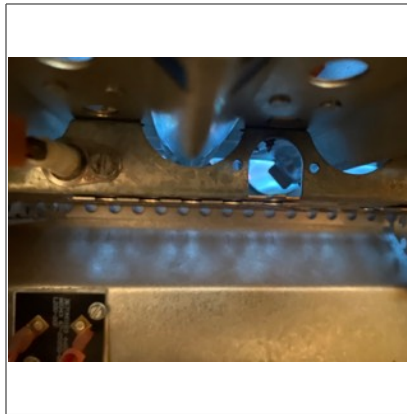
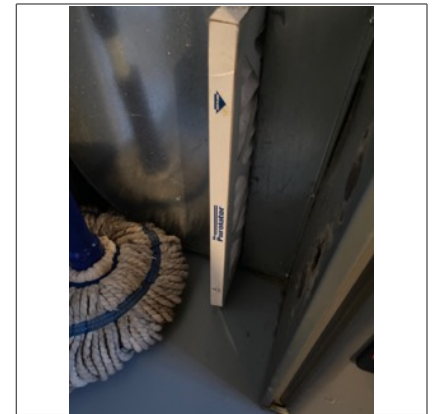
Comments Furnace was in normal working order at the time of the inspection.
 Heat exchanger had limited visibility due to its high-efficiency design.
 Recommend having ductwork cleaned.
 Filter should be changed monthly.
 Carbon monoxide tested. 17 ppm
 Furnace is rated at 92% efficient

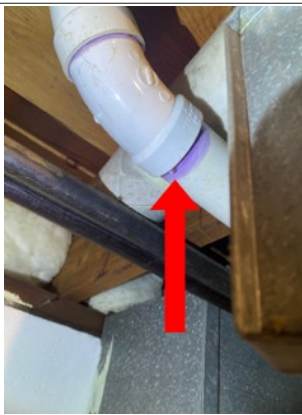
Condensation is dripping from the vent line. Recommend repair in resealing around this joint
